Professor Scott Lockyer FIMMM CEng

Uniper Technologies Limited

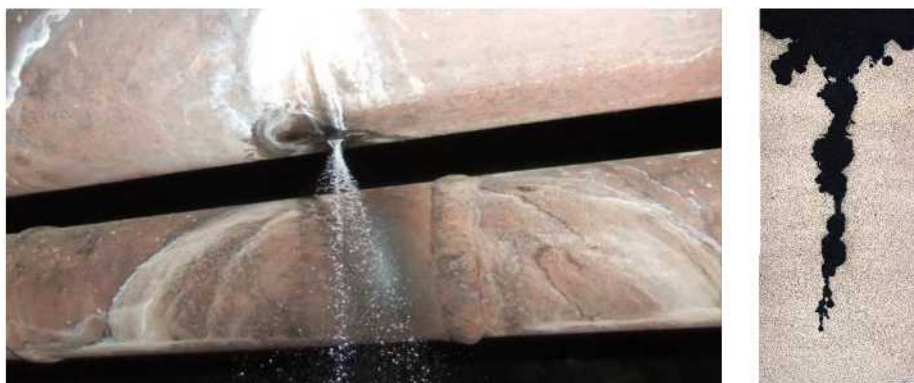
Component failures can however still occur and it is vitally important that the cause is correctly identified to allow mitigation measures to be put in place to prevent repeat failures. In many cases the failure is a result of changes to operating conditions that were not considered in the original design, a good example is the increasing amount of renewable generation resulting in conventional power plant operating flexibly, i.e. switching on and off to provide power at times of peak demand. Components primarily designed for constant (baseload) operation with a design life based on hours of operation, are now life limited by the number of plant starts/stops. In terms of damage this results in a change from creep dominated to fatigue dominated mechanisms, which can manifest as thermal fatigue, corrosion fatigue, etc. The images below show a classical corrosion-fatigue crack and a leak resulting from this damage mechanism.

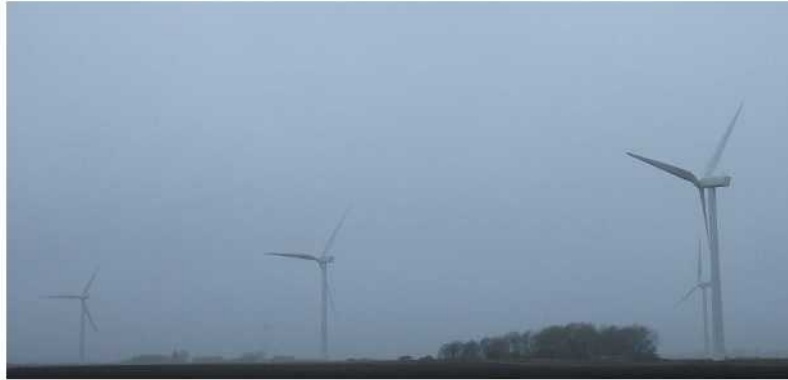
In some cases failures can occur because the actual service conditions are not fully understood, are more onerous than assumed and/or the selection of poor design features. Understanding which of these have contributed to a failure can allow selection of more appropriate materials, design modification, development and implementation of repair processes. One such failure occurred when routine inspections identified extensive cracking in the nacelle bedplates of a number of wind turbines. The bedplate is the framework that supports all the equipment in the turbine nacelle, i.e. the hub, main shaft, gearbox, generator and transformer, and is therefore critical to the integrity of the turbine. In this case an in situ repair process was developed alongside an inspection method to

accurately measure the crack lengths, monitor their growth and, where possible, underwrite continued operation of the turbines whilst awaiting repair. The repair process presented challenges due to the bedplate being galvanised, the cracks requiring large gap welding and restricted access, all whilst working in the turbine nacelle many metres off the ground. To ensure good quality repairs, the weld repair process was qualified, as were all the welders who undertook the repairs. The repairs were successfully undertaken and to date there has been no re-occurrence of the cracking on any of the repaired turbines.
